Upgrading BOS firmware Manual

This manual will cover the steps for upgrading your BOS (Battery Operated Sensors) firmware so they will work and successfully synchronize with your existing L-DCIM that is running the latest software version.

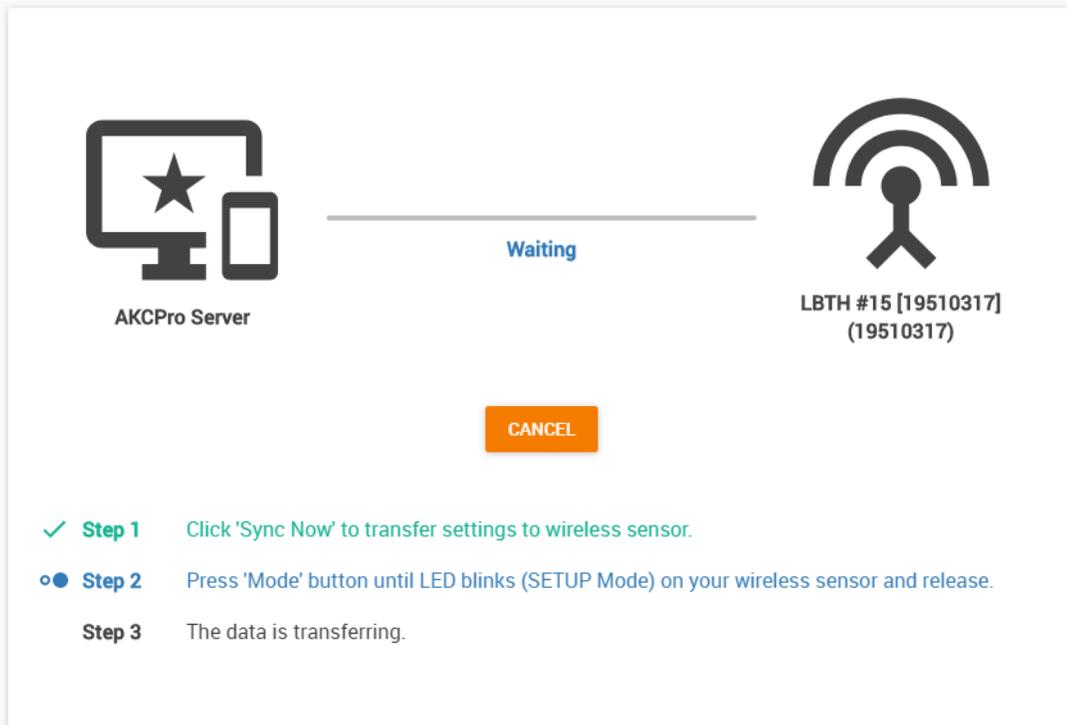
3. The AKCPro Server (L-DCIM) then prompted you to sync with the new device, however when you attempted to do so by completing the prompts on the screen stating “press the ‘mode’ button on the BOS until it blinked”, which it did, however, the sync wizard does not proceed from step 2 and doesn’t finish the sync:

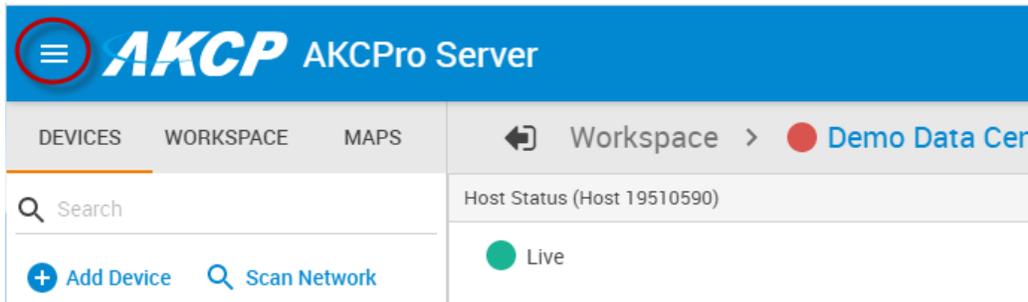
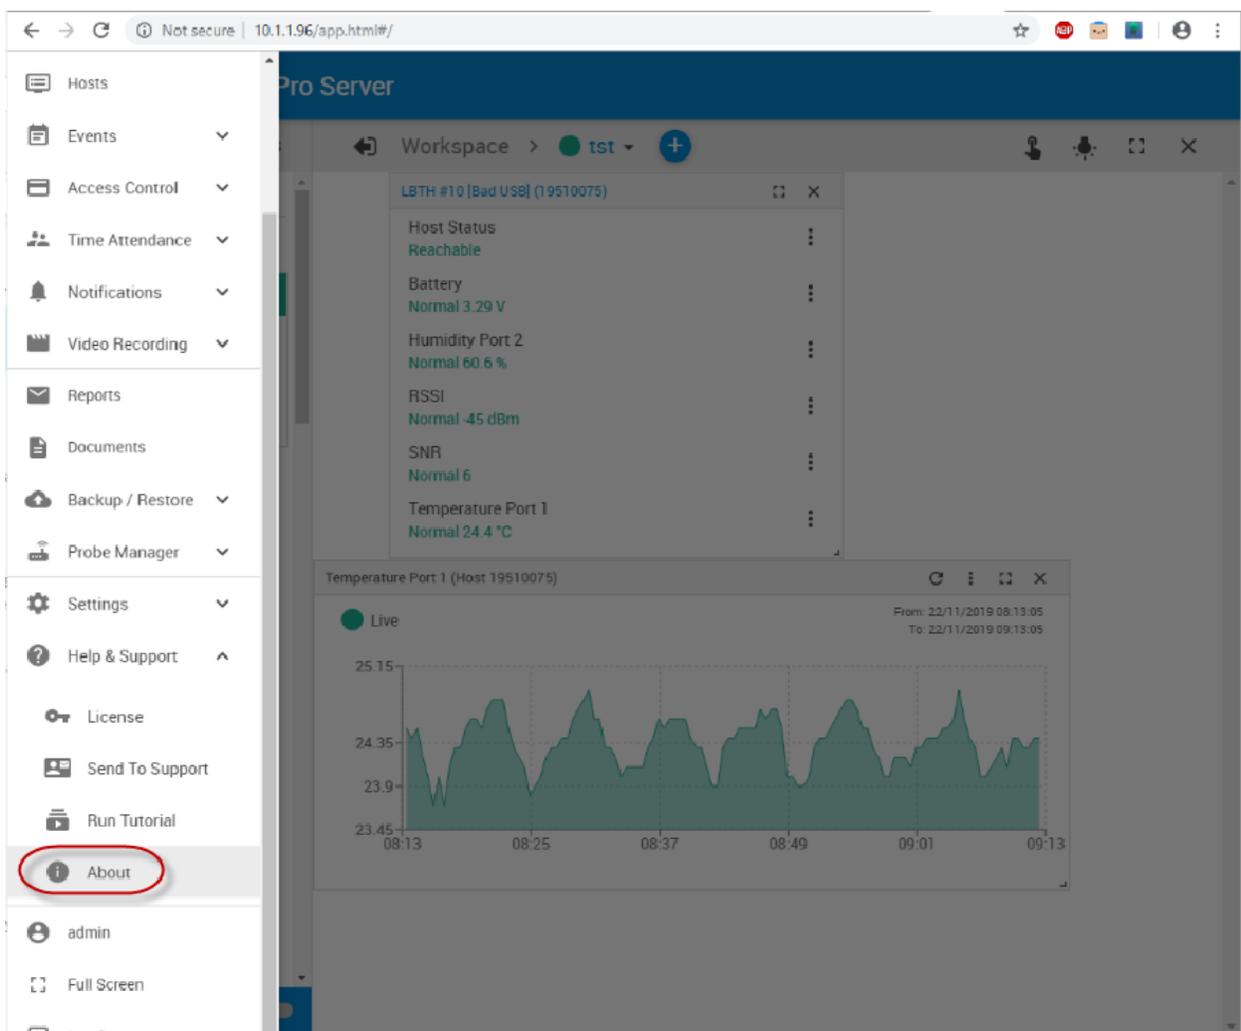
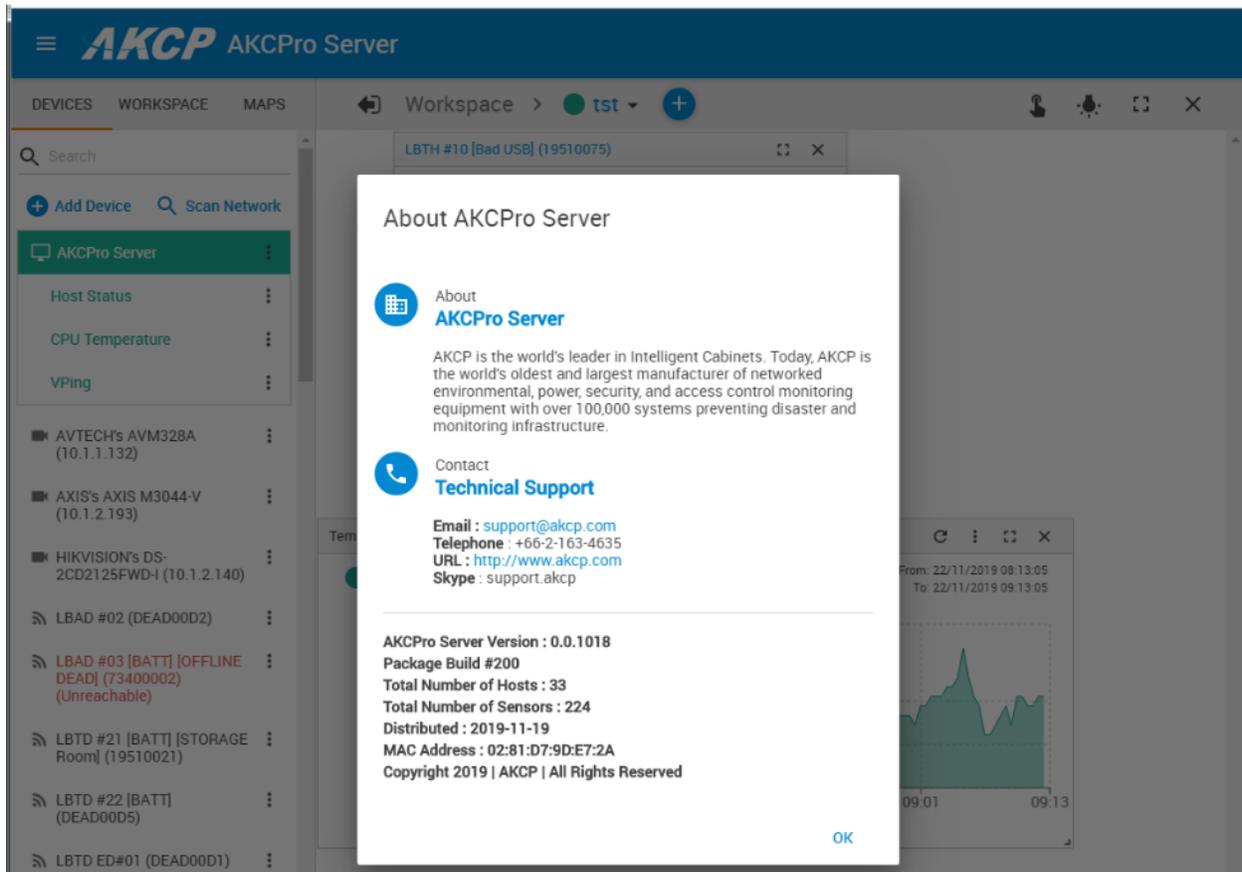
A. The first screen shot to send us is the version of the software running on your L-DCIM:

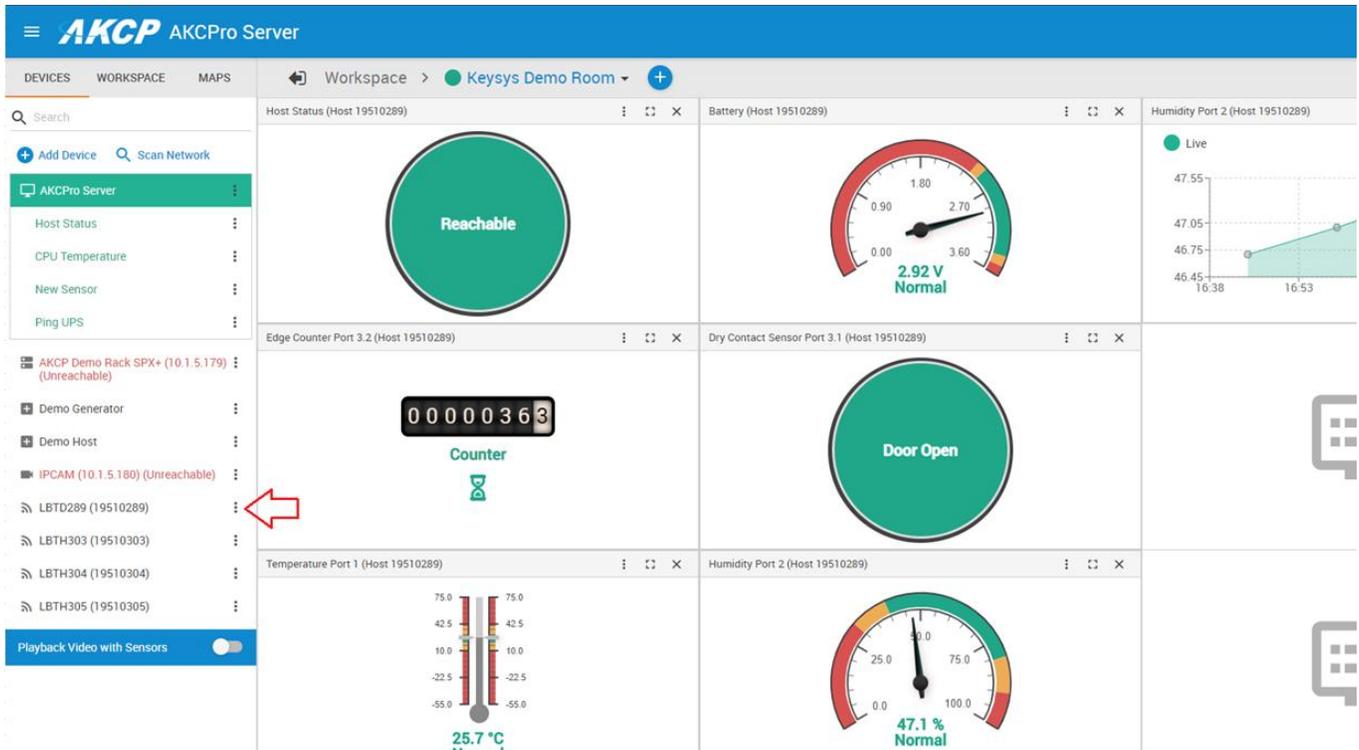
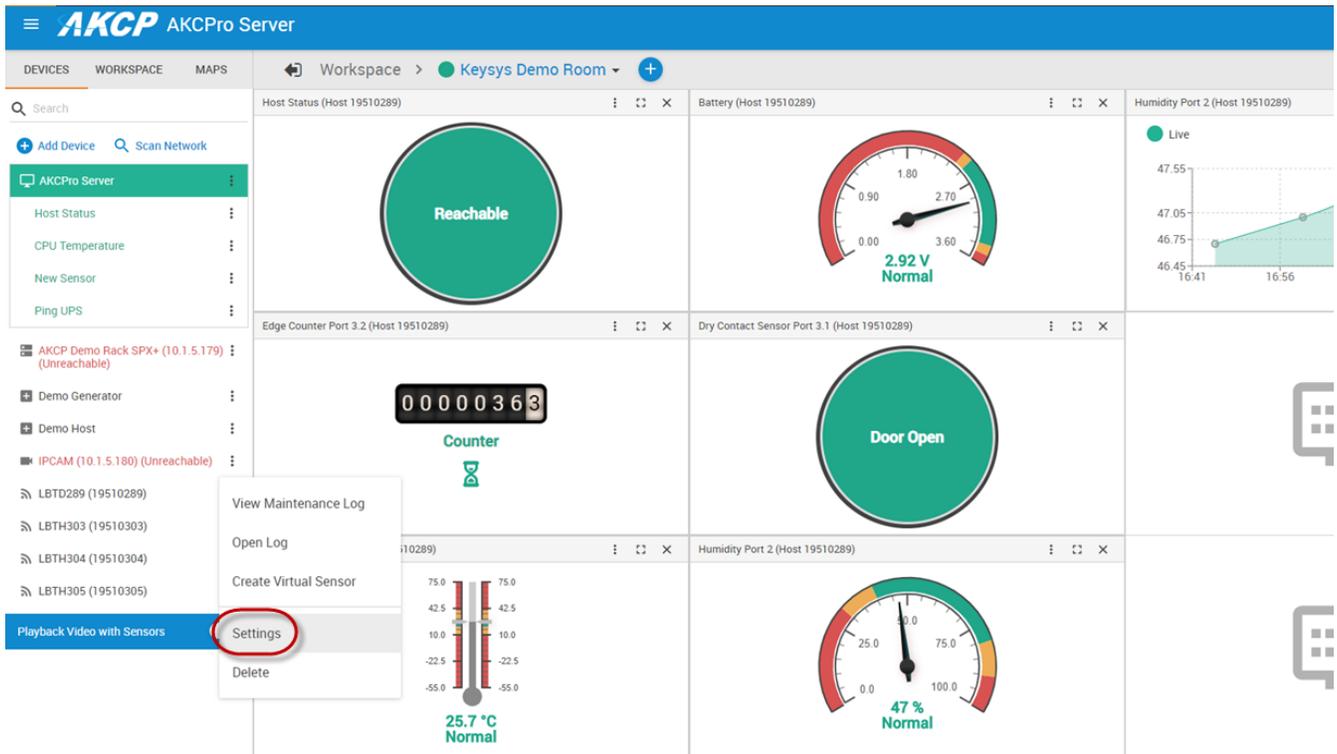
- B. The second screen shot to send is the current version of the BOS that you received. To check the BOS firmware version, first click on the 3 dots next to the wireless sensor(s) as shown in the screen shot below that are not synchronizing.

Then click on the **Settings** link as shown in the screen shot above.

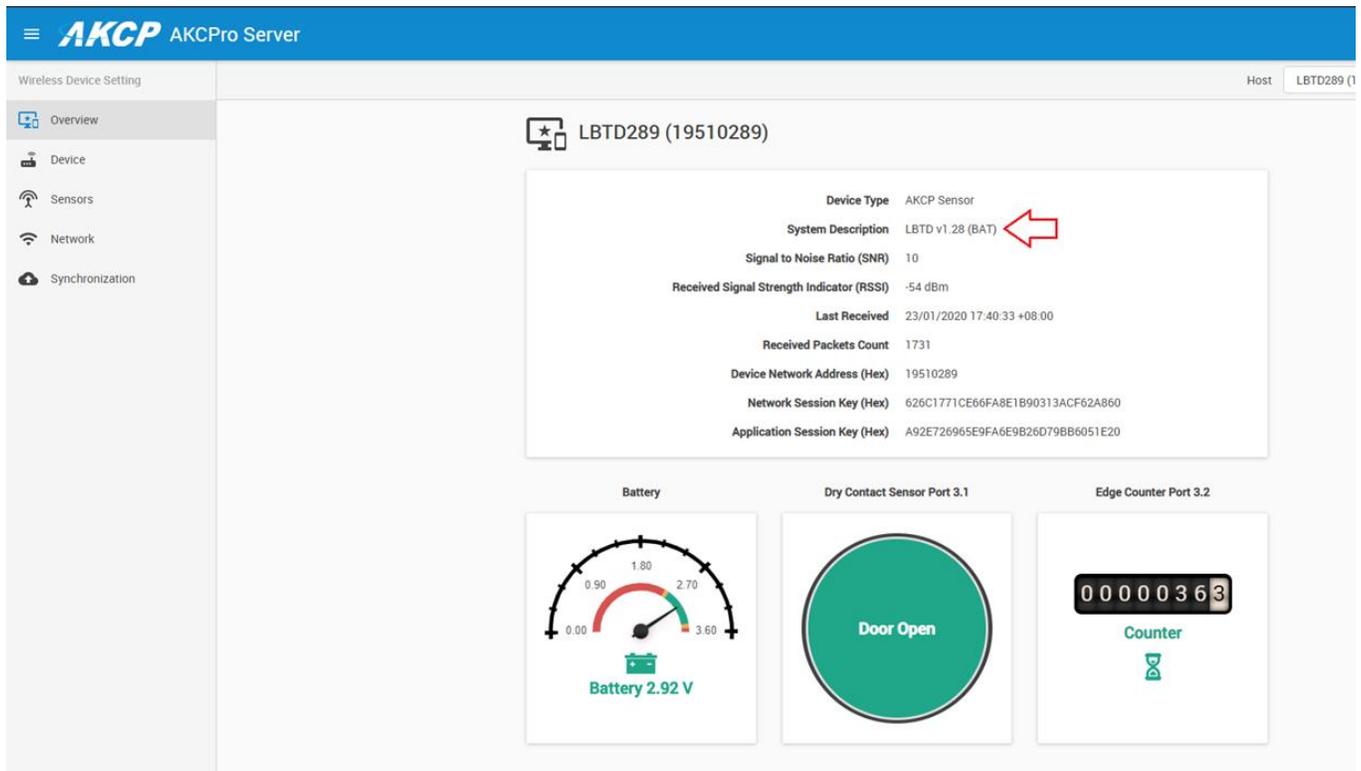
Then see the **System Description** for the BOS firmware version and send this information to AKCP support as shown in the screen shot below.
